# Coastal Erosion and Sea Wall Construction in The Bahamas

by  
Neil Sealey

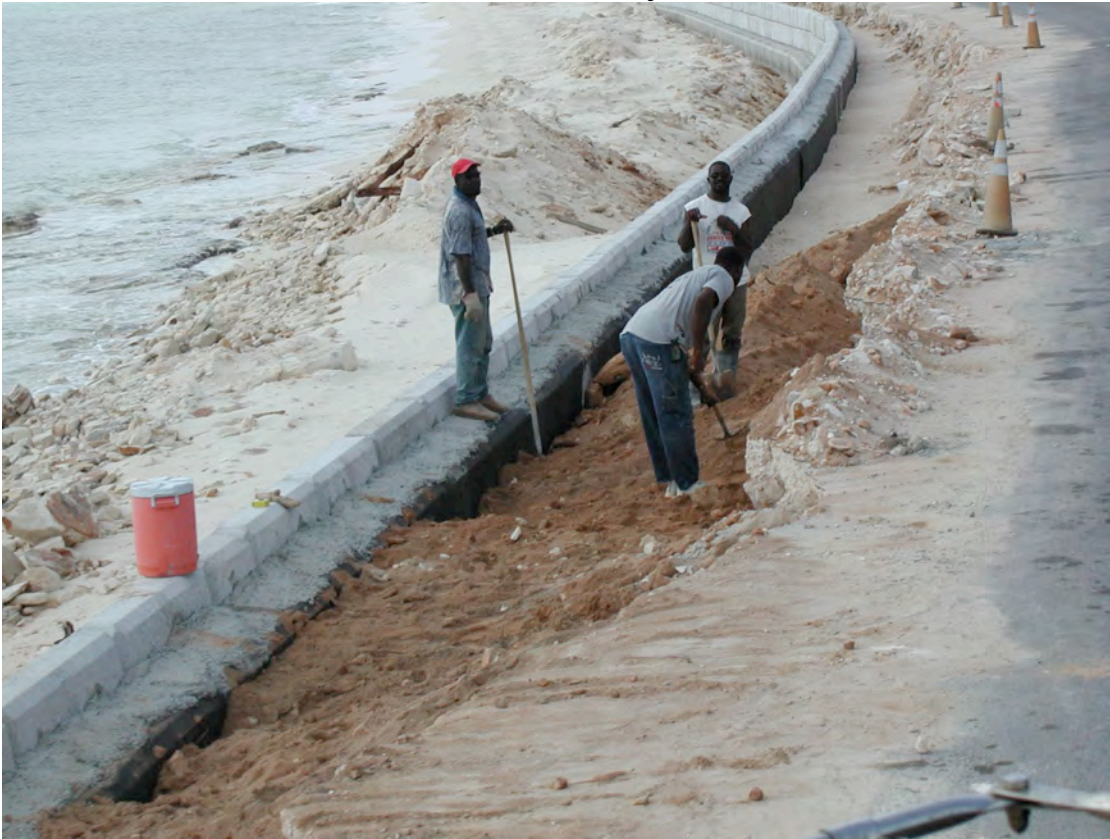
**Work on a sea wall on San Salvador**

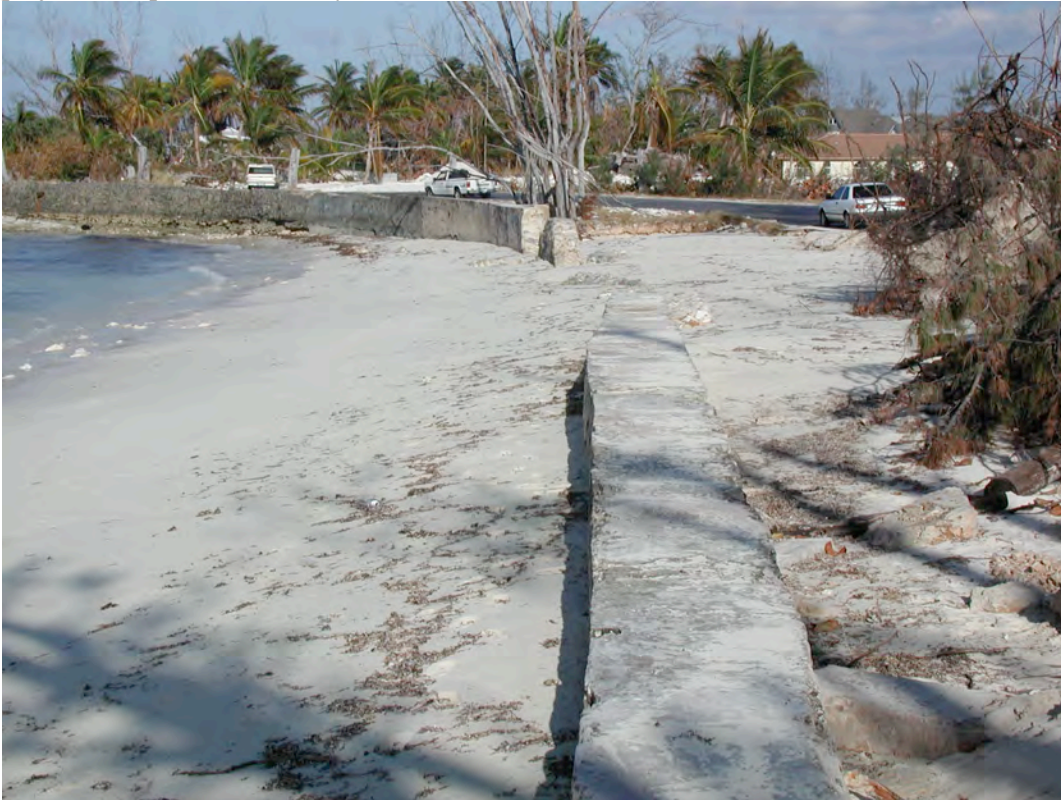
**Breached sea wall at West Bay Street, New Providence.**

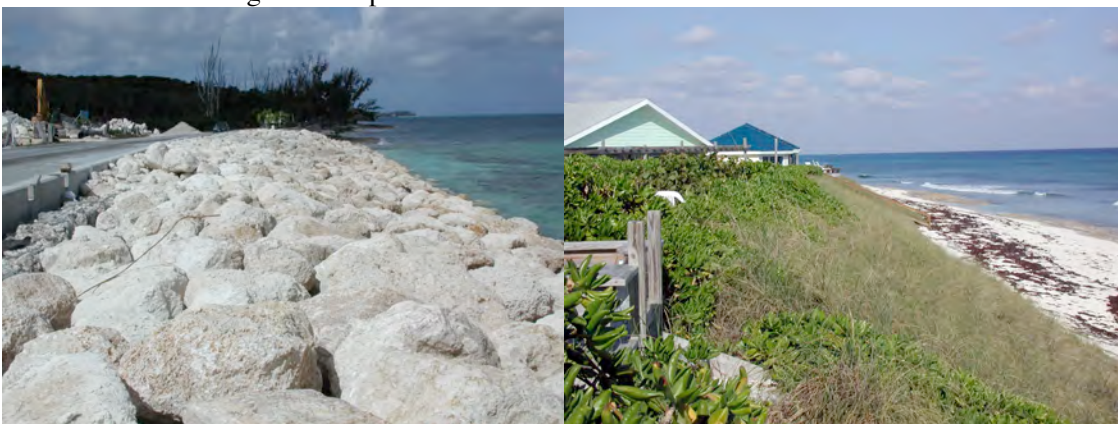
**Revetment along West Bay Street, NP.**

**Rebuilt dune at White Sound, Elbow Cay, Abaco**

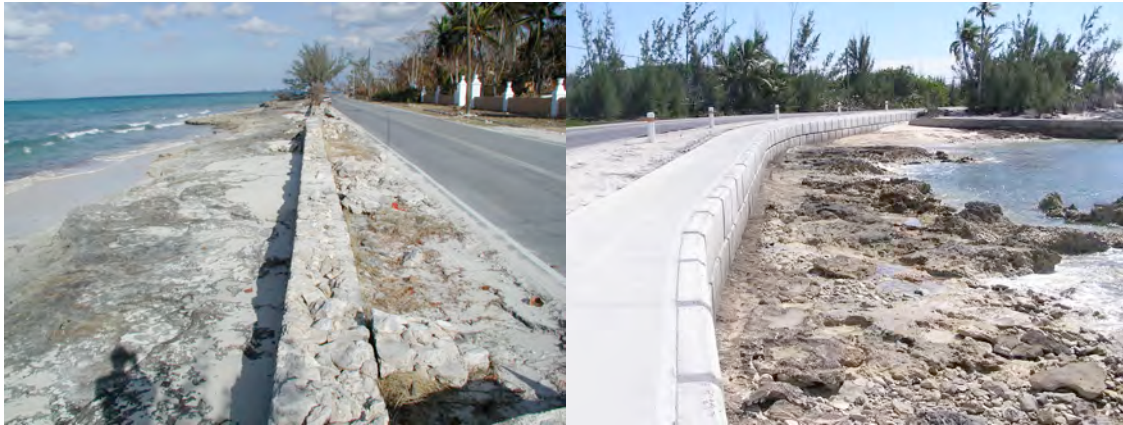
**Proximity of road to shoreline on New Providence and Cat Island.**

In the case of The Bahamas shoreline erosion is due to number of factors which may include offshore dredging, stealing sand from beaches and sand dunes, construction on the beach or immediately offshore, or vegetation removal. But the main cause in the recent spate of sea wall building has been the construction of roads too close to the shoreline in the past. This has meant that the natural processes of beach and dune development have been interrupted, with resultant erosion. An examination of the sea walls on West Bay Street reveals that they are all located where the road is close to the shoreline, and this is what caused the problem originally. To further protect the road new walls, as at Gambier, or rebuilt ones, as at Rock Point, have been built. Apparently no thought has been given to moving the road back from the shoreline and restoring

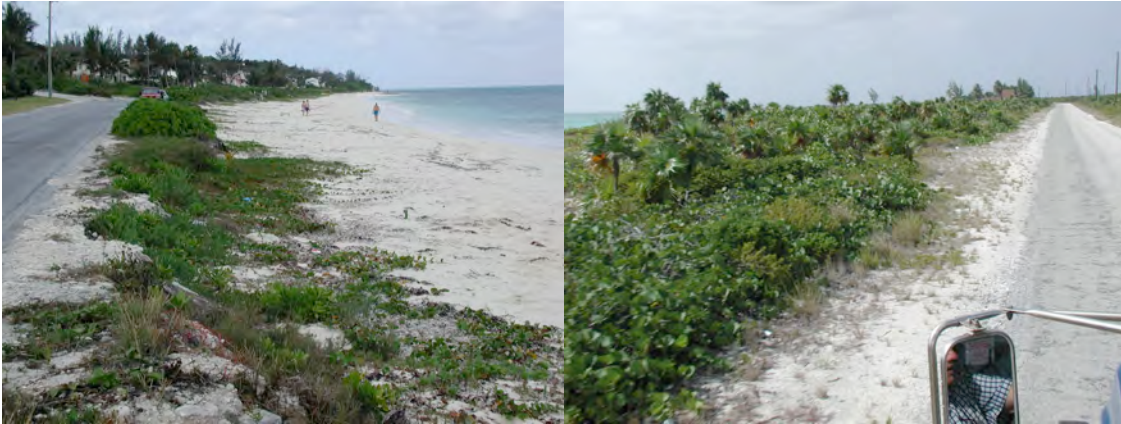
**Deteriorated sand dune at Orange Hill, NP      Road safely behind dune on San Salvador**

Wherever the road is further away there is no erosion, and clearly all that has to be done is to move the road back from the shoreline area, and in this case there is plenty of room. A similar situation exists along the west coast of Cat Island from Tea Bay to Smith's Bay Settlements, and once again moving the road would ensure its future security, as well as restoring the amenity of the beach. In the case of Cat Island the situation is worsened by the fact that the ends of the walls have not been finished properly and are already failing, so have to be repaired. In fact this is an enduring problem with sea walls, which, far from being self-sustaining, are actually self-destructive.

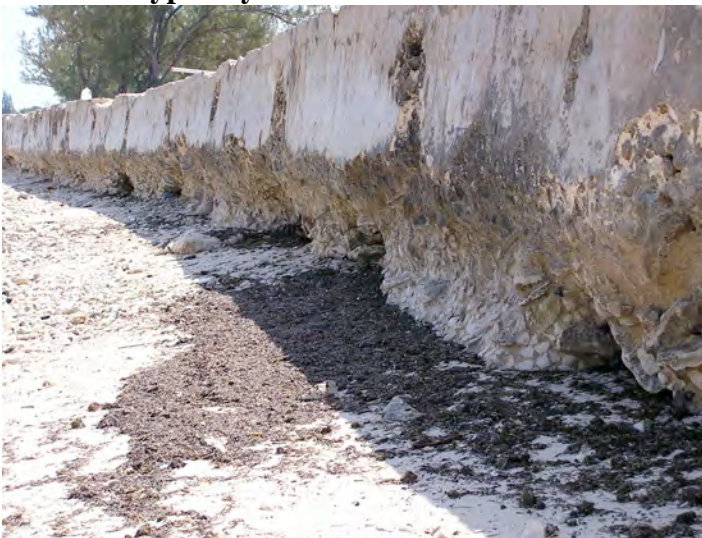
**Severe scouring is associated with many Bahamian sea walls**

**Scouring.** As the wall presents a vertical face to the waves, the waves are reflected back and scour sand and rock from in front of the wall. This increases the drop to the sea floor and leads to the eventual collapse of the wall. This is why the huge boulders, commonly referred to as rip-rap but also described as beach armouring, have been placed in front of the revetment west of Rock Point on West Bay Street. The rip-rap breaks up the waves and prevents scouring, eventually leading to sand accumulation at the foot of the boulders. This started appearing on West Bay Street at low tide about 2 years after the wall was built. However this is an expensive and partial solution. Without the road or the wall the sand would have come back anyway. This is also an indication of what will be required of all the walls presently without armouring – sooner or later this expensive and ugly procedure will be needed to protect the walls that protect the road that destroyed the beach. And of course any new beach will be virtually inaccessible anyway.

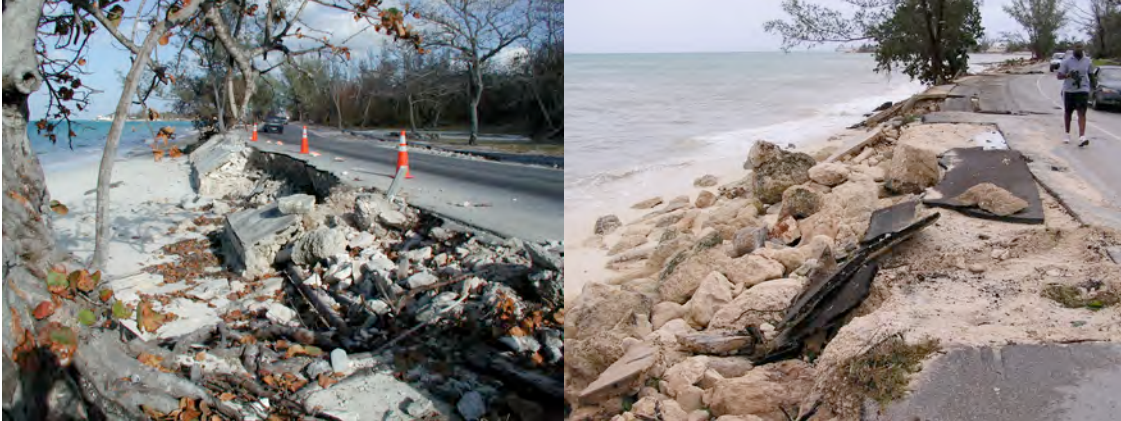
**Sea wall failure at Caves Point, NP, after H Michelle (2001) and H Frances (2005)**

**Wall Collapse.** It has been indicated that walls create conditions for their own demise, but apart from that, unless built to extremely high (expensive) standards, they will fail for other reasons. The sea defences built at the Caves Point failed after Floyd, again after Michelle, and again after Frances, and photos taken at the time show almost exactly the same destruction of a badly built wall. In essence this wall was simply a lot of fill with a skin of concrete over the top. Waves broke over it and washed back under it to push the top off and expose the fill inside. The more recent walls are designed to prevent this with much stronger design components and back-water drainage channels.

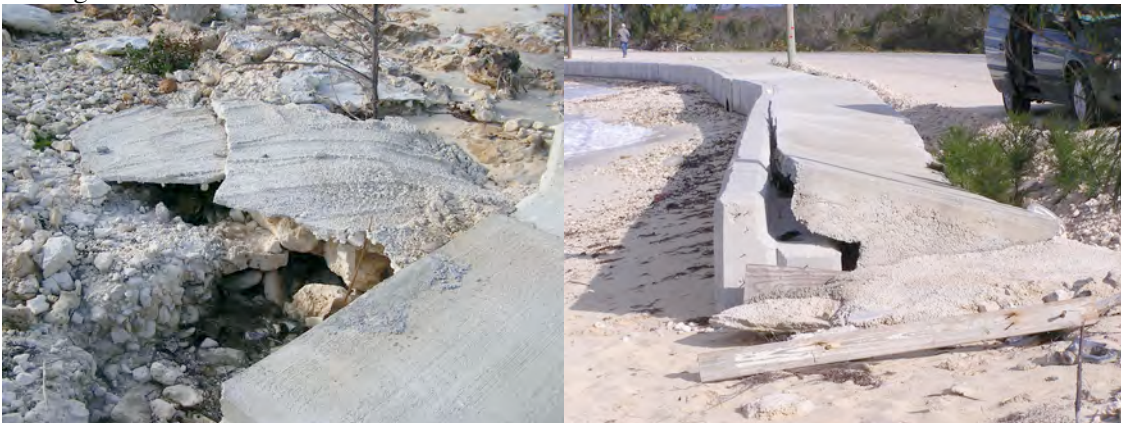
**Improperly finished wall end; and wall collapse due wall end failure, both Cat Island.**

**Wall-end failure.** Unlike San Salvador, which has one continuous wall, Cat Island has a series of walls at each point where the road was threatened or washed away. In every case the ends were

not finished properly and have started to erode, and eventually the seawalls will collapse from each end towards the middle. This is already happening at one location.

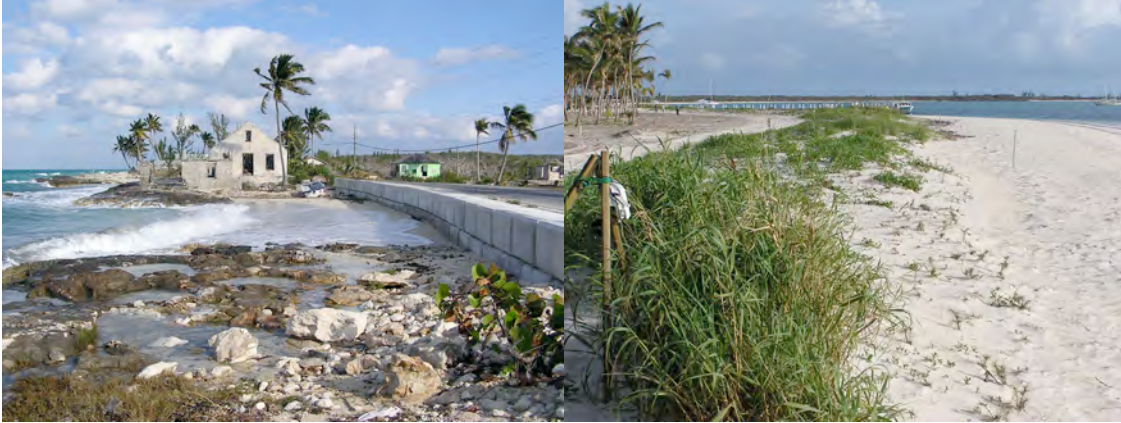
**Construction should not be allowed where it affects coastal processes – Cat Island.**

**Dune rebuilding is simple and can also create an amenity – Guana Cay, Abaco.**

**Dune rebuilding.** Where the dunes have been lost, as on San Salvador, or at Orange Hill here on New Providence, they need to be rebuilt with sand from the immediate locality. This of course needs to be done in conjunction with beach feeding if necessary, and with vegetation replanting. A successful example of dune restoration is currently being monitored on Guana Cay.

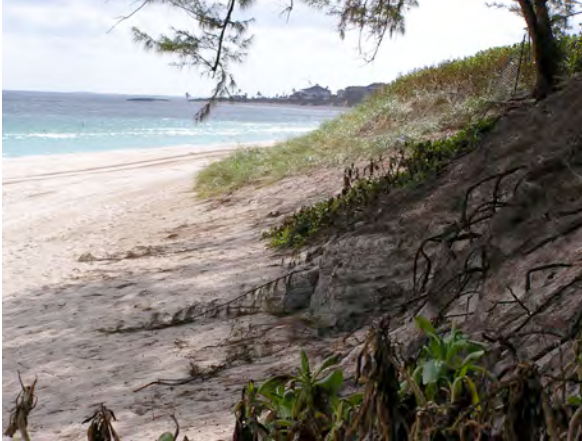
**Partially re-vegetated dune (background) on Paradise Island.**

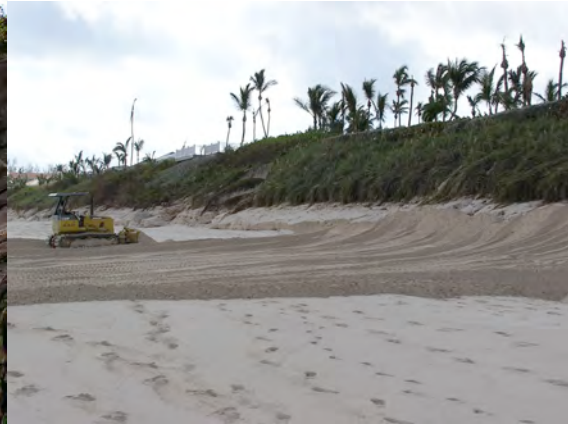
**Scraping sand back to dune after H Frances, Paradise Island.**

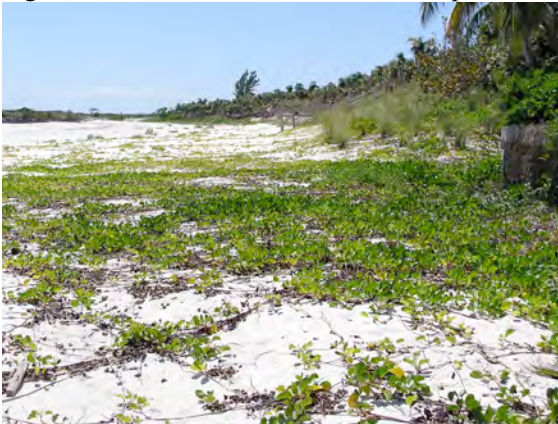
**Natural beach regeneration after H Floyd, Windermere Island, Eleuthera**

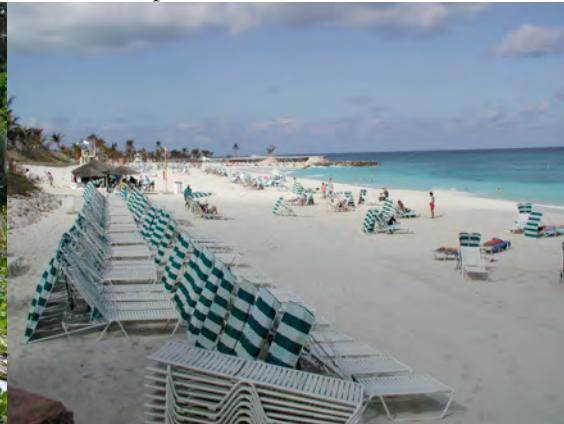
**Replenished beach on Paradise Island immediately after H Michelle, 2001.**

**Beach nourishing.** This essentially means adding sand to the beach to restore it to past levels, a process well known from southern Florida's beaches and practiced along much of the eastern seaboard of the USA. If done with a proper understanding of the dynamics of sediment movement along the shoreline and with the appropriate sand this can be a pleasing and self-sustaining fix.
